Nitto Case Study

Major Airline Saves Money on Corrosion Prevention Tape

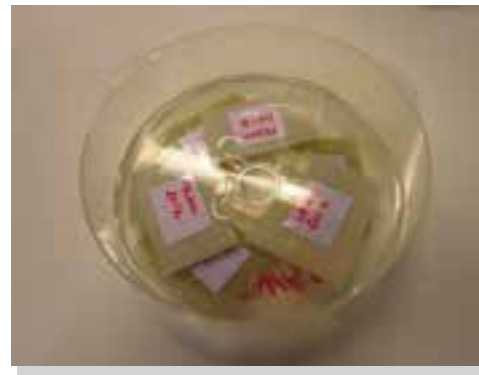
Soak test

The first part of the evaluation process was simple soak tests. They were performed on the three new products to determine the ability of the bond line to prevent moisture ingress under the tape, thus protecting the metallic structure from being exposed to moisture and prevent corrosion. Samples of all three products were bonded to clear plastic discs and soaked in four different fluids for 50 days.

AEROSEAL® SC-140 performed satisfactory and Products B and C were found to have full bond line penetration. A second set of soak tests was performed, with results similar to the first test. After both soak tests were completed, Product C was rejected as it did not meet expectations.

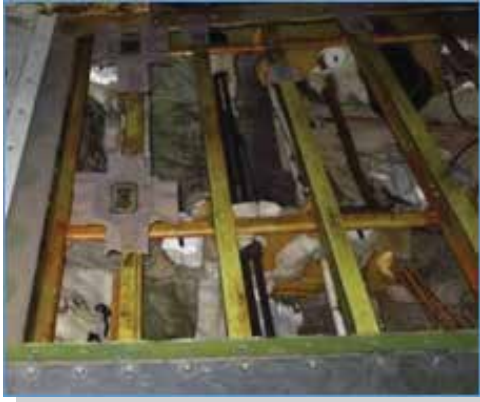
Aeroseal® SC-140 on floor structure

The final step in the evaluation was to test the final two products, AEROSEAL® SC-140 and Product B, on a 737-800 airplane operating in Guam for two dedicated corrosion inspection cycles. The two products were applied in the cargo floor structures with AEROSEAL® SC-140 in the forward cargo compartment typically used for hauling fish – the ultimate corrosion test.

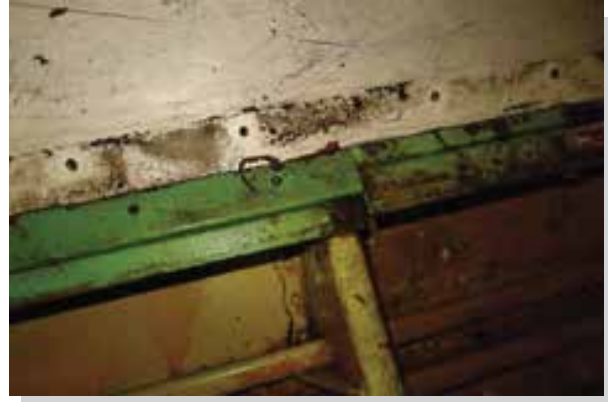
Aeroseal® SC-140 removed cleanly from floor structure

At the first inspection cycle after 120 days, no corrosion was found in the forward cargo floor structure sealed with AEROSEAL® SC-140 - despite evidence of a fish spill. The cargo panel removal for the entire forward cargo compartment was completed within 40 minutes. Little to no tape residue was found on the structure after removal.
